**CWA COMPLIANCE EVALUATION INSPECTION REPORT**  
**U.S. ENVIRONMENTAL PROTECTION AGENCY, REGION 5**

**Facility:** E&R Livestock  
Ex. 6 (Personal Privacy)  
[REDACTED]

**Date of Inspection:** 9/18/2013

**Report Date:** 7/1/2014

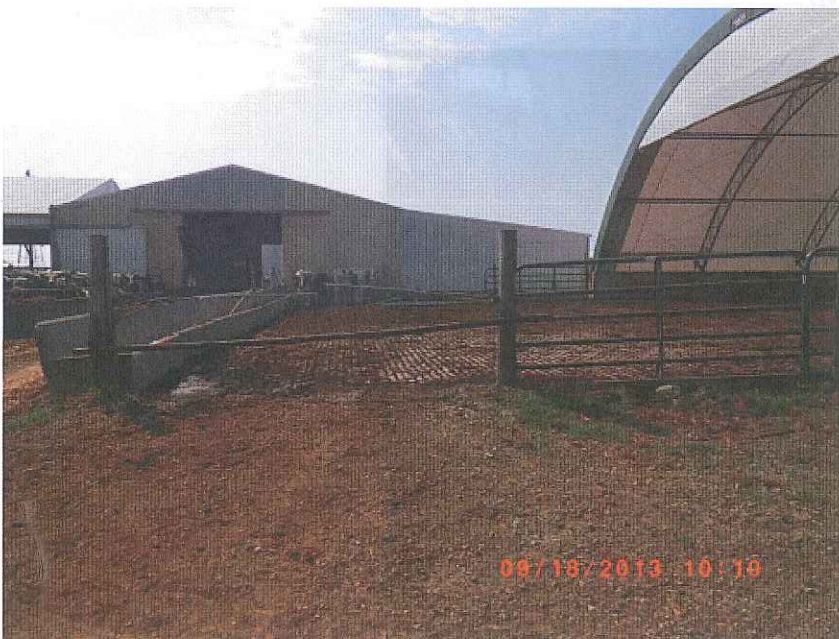
IMGP0353: Open pen for hoop barn is on the east side of the barn.  
 Location: North of pen 6.  
 Facing: South  
 Date/Time: 09/18/13 11:10 A.M.

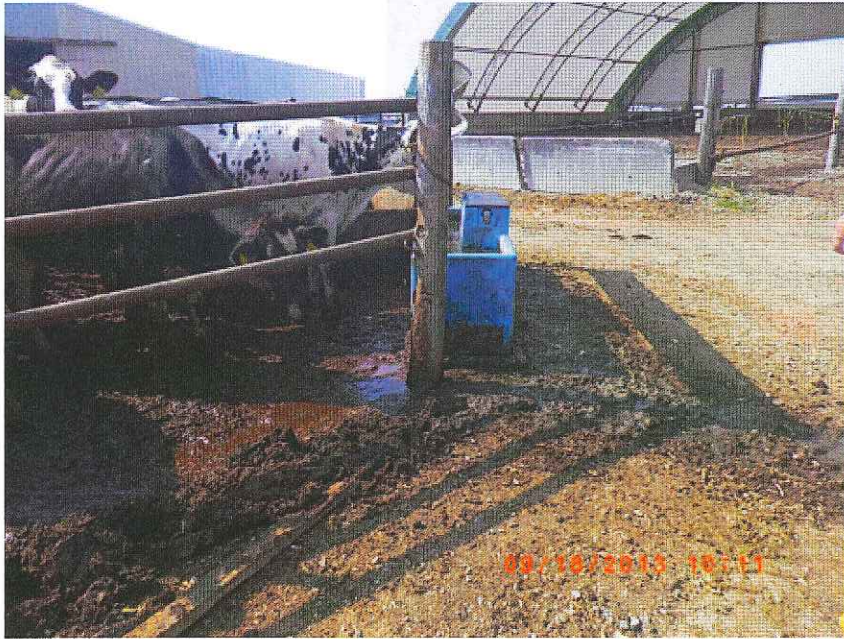
IMGP0354: Manure and process wastewater that runs off from this pen, Pen 6, flows to the east and to the concrete manure pit.

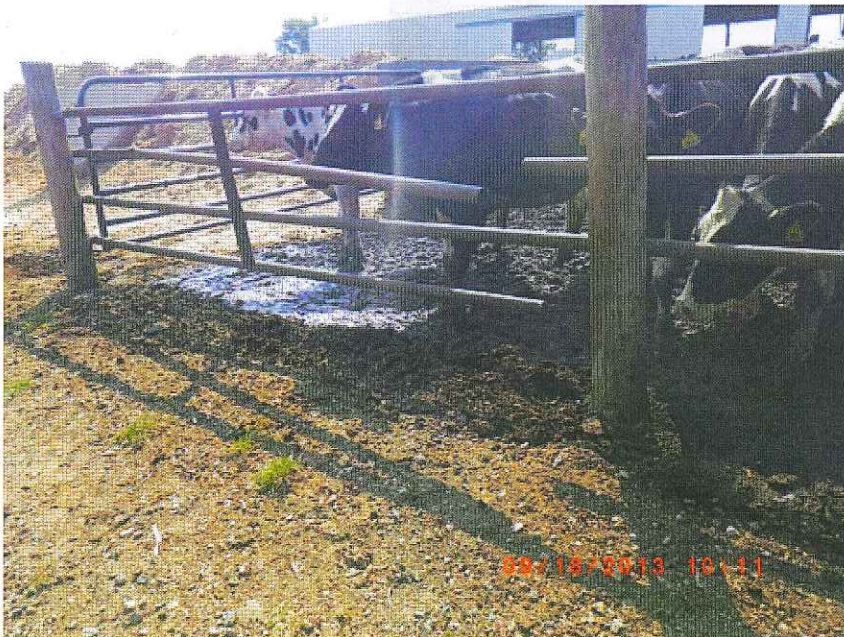
IMGP0355: Manure and process wastewater that runs off from Pen 6 flows to the east and to the concrete manure pit.

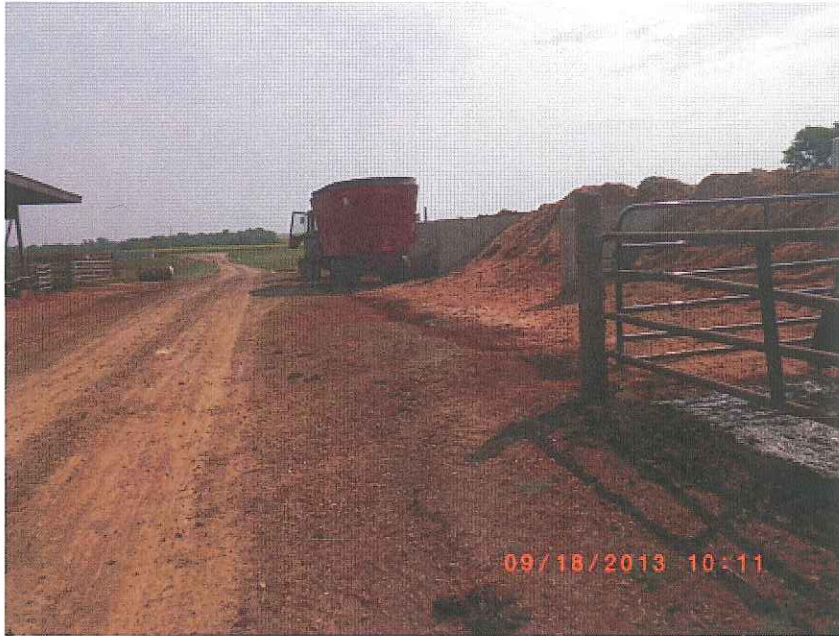
IMGP0356: Sawdust is stored in bays east of Pen 6.

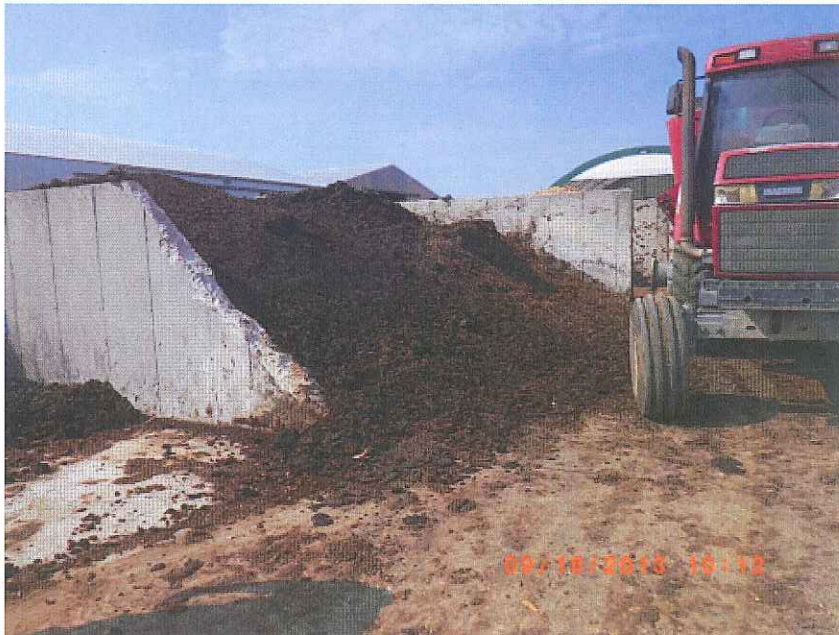
IMGP0355: Manure solids are stored in the bays east of Pen 6. Process wastewater from the bays would flow to the east and to the concrete manure pit.
